# St. Andrew's Tennis Courts

## Geotechnical Engineering Report

February 27, 2026 | Terracon Project No. EN255198

Re: Geotechnical Engineering Report  
St. Andrew's Tennis Courts  
1095 Playground Road  
Charleston, South Carolina  
Terracon Project No. EN255198

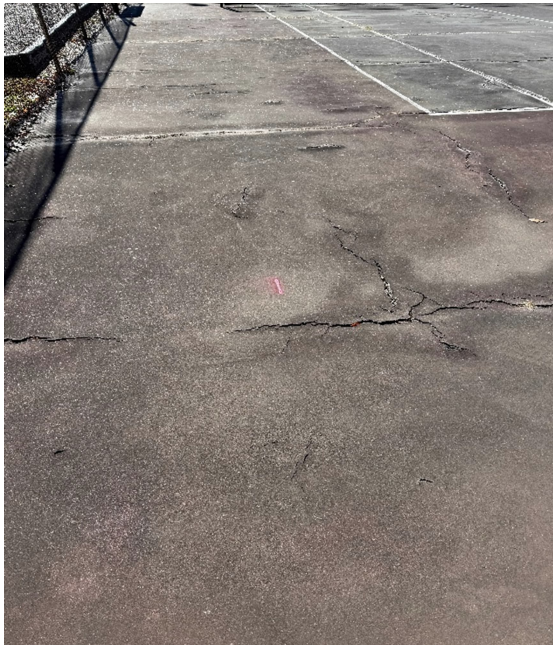
Photo 1: Cracking, depressions, and water stains at DCP-1

Based on the results of our field testing and observations, we were able to identify some likely potential causes of the conditions observed across the tennis courts. At the front three courts the thickness of the court surface ranged from 1 to 3¾ inches, overlying an aggregate base course that ranged from 1½ to 6¼ inches thick. This variability in the court section thickness could result in uneven compression and expansion due to temperature fluctuation resulting in heaving and cracking. The courts were also constructed prior to 2003, being at least 23 years old and do not appear to have been improved during that time. These courts may be at the end of their design life period.

The subsurface conditions underlying the front three tennis courts were relatively consistent and the DCP testing results indicate the near surface subgrade soils are relatively dense. However, there is a layer of soft fine-grained soils with trace organics roughly 2 feet below the court surface. These soils have a higher fines content and may be causing a perched water condition. These perched conditions and water fluctuations can

lead to piping of fine sands and the creation of voids within soils and/or organics. As these voids enlarge, the potential for settlement of the surface increases.

Therefore, in our opinion, the observed distresses at the front three courts are caused primarily by variable court surface thickness, poor surface drainage, and perched water conditions. As cracks developed over time, surface water was able to enter the subgrade and due to the presence of a more clayey soil, the water perched between the court and underlying subgrade causing further distress and cracking. To improve performance of these courts in the future, consideration should be given to the following options.

- Installing a more uniform tennis court section would prevent cracking due to environmental factors such as temperature and moisture fluctuations.
- Existing grades can be modified to promote positive drainage.
- Consideration can be given to removing the clayey soils and replacing with a better draining material.
- Underdrains can be incorporated to carry surface water away from the court subgrade soils.

We recommend the front three tennis courts closest to Playground Road be removed and an improved subgrade be established as described in [Earthwork](#). This would create a uniform subgrade and reduce settlements across the entire court. A new tennis court surface uniform in thickness could then be placed on this stable subgrade. A new subgrade would also prevent the piping of water under the tennis court. Consideration should be given to modifying existing grades to promote positive drainage and/or underdrains should be incorporated to carry surface water away from the court subgrade soils.

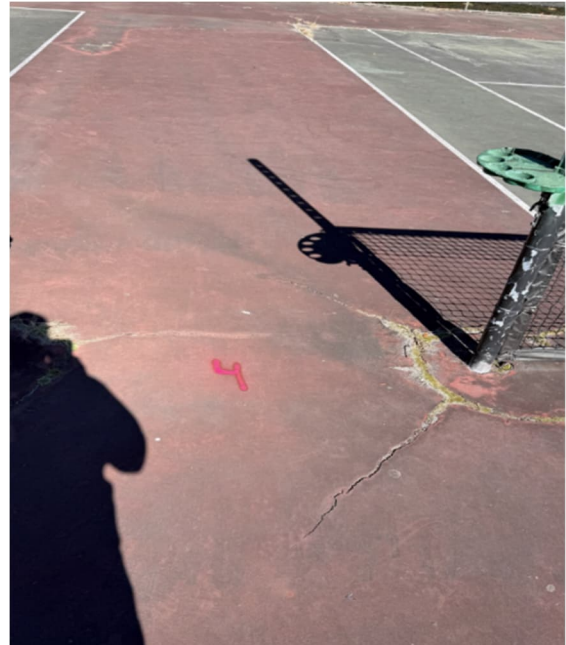
Photo 2: Cracking at net poles at DCP-4

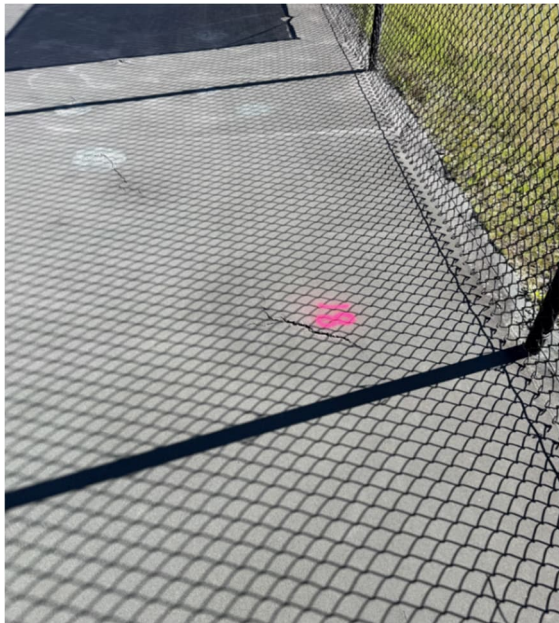
Photo 3: Small cracking at DCP-18

For the other eight tennis courts, only minor cracking was observed. These courts have been resurfaced within the last 13 to 14 years and the encountered subsurface conditions were much more consistent than those at the other three courts. The observed cracking is likely due to settlement over time as it appears to be isolated to small areas and at the net poles where a larger force is present due to the torquing of the net.

The remaining eight courts generally appear to be in good condition and are not exhibiting signs of severe distress. Since subgrade and moisture issues are not a concern here, the rear eight courts are candidates for resurfacing or they can simply be repaired in a manner that is typical of the industry. A crack repair system similar to Figure 1 below may be a feasible option.

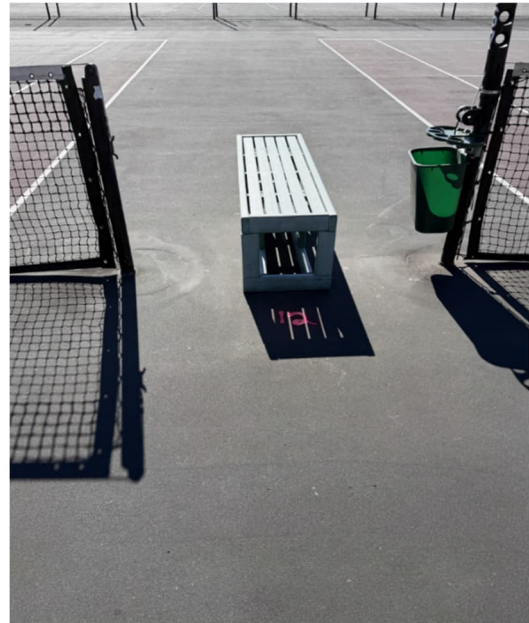
Photo 4: Small cracking at net poles at DCP-12
